## **Appendix A: Historic and Current Photographs of Merrimack Village Dam and its Surroundings**

- **Historic Photos (Photos 1-10),**
- **2/22/03 (Photos 11-15),**
- **6/12/03 (Photos 16-19),**
- **10/20/03 (Photos 20-25),**
- **6/3/04 (Photos 26-28),**
- **6/29/04 (Photos 29-36),**
- **6/30/04 (Photos 37-39),**
- **10/27/04 (Photos 40-44).**

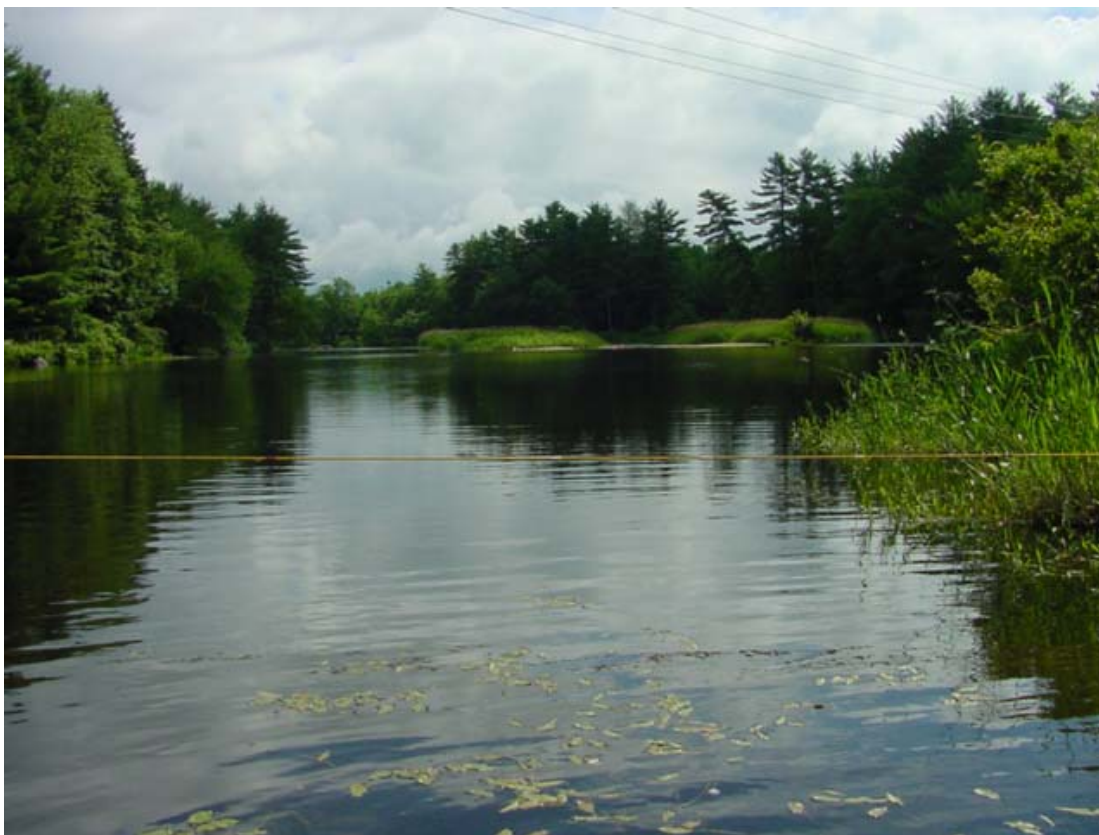
Photo No.: 29, Date: 6/29/04, Mean Flow at Souhegan River Gage: 72 cfs  
Description: Downstream view from transect T-7

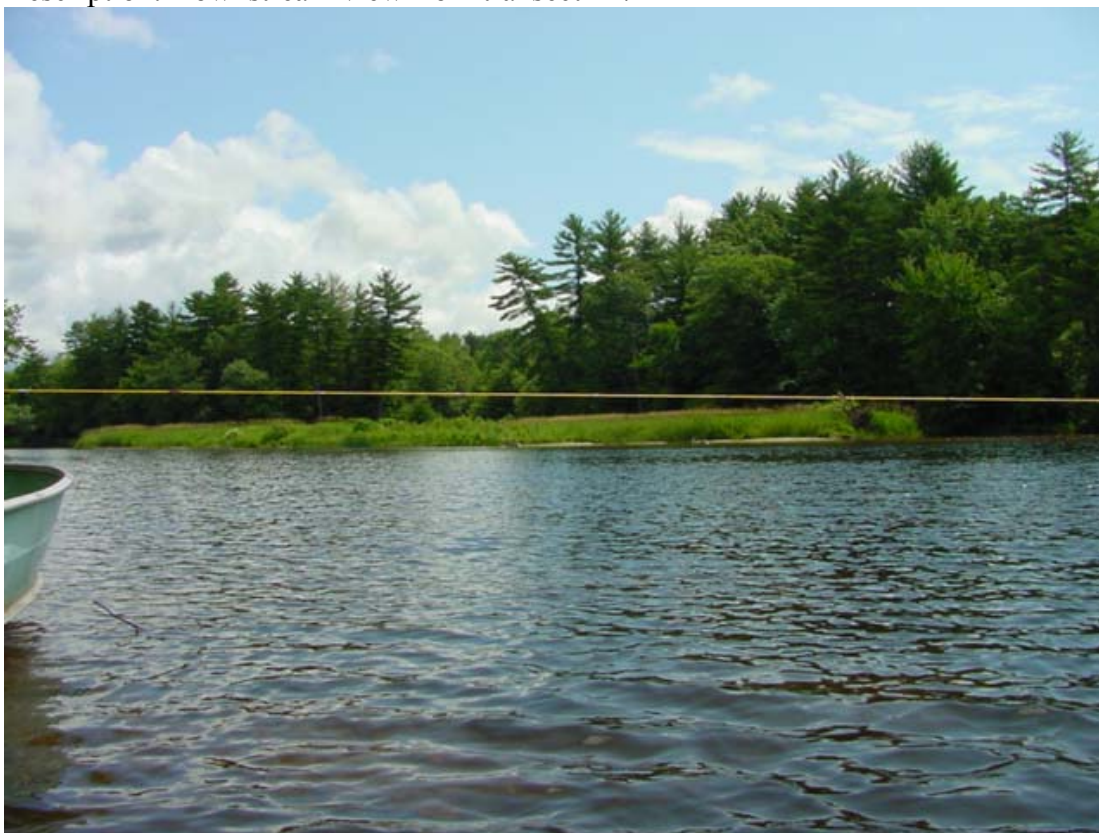
Photo No.: 30, Date: 6/29/04, Mean Flow at Souhegan River Gage: 72 cfs  
Description: Downstream view of transect T-6

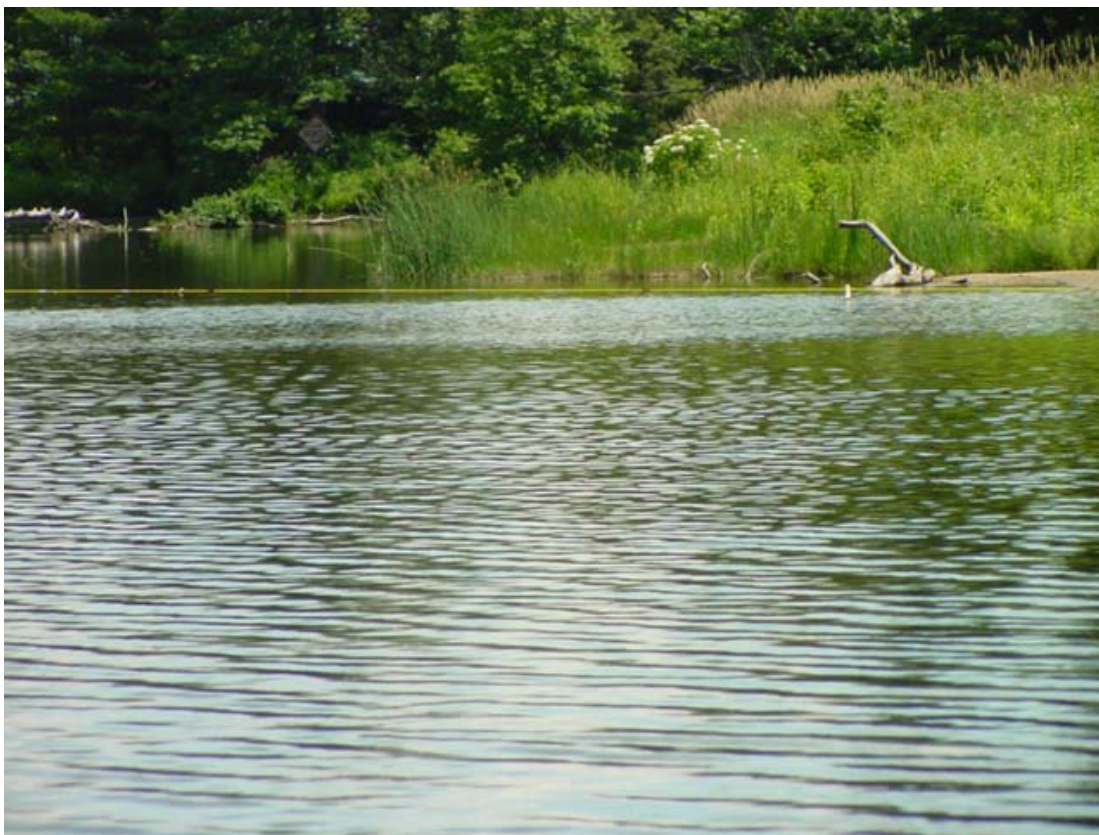
Photo No.: 31, Date: 6/29/04, Mean Flow at Souhegan River Gage: 72 cfs  
Description: Downstream view of river-left from transect T-5

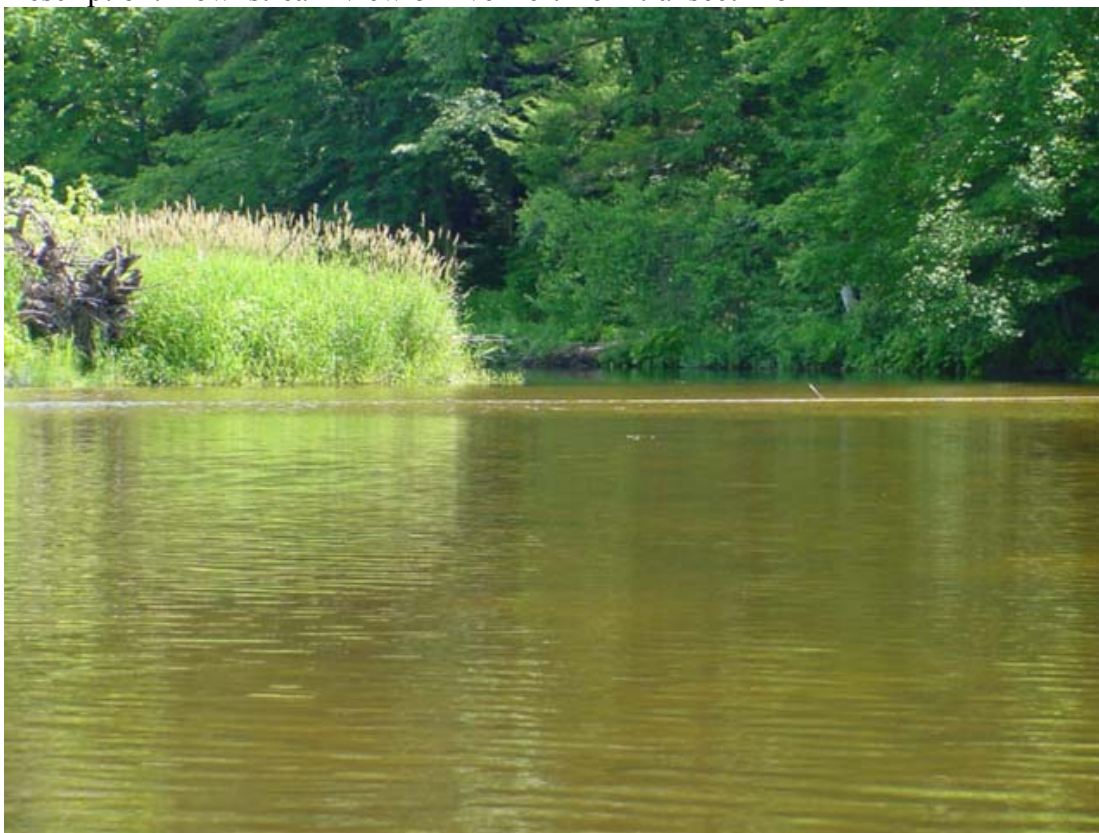
Photo No.: 32, Date: 6/29/04, Mean Flow at Souhegan River Gage: 72 cfs  
Description: Downstream view of river-right from transect T-5

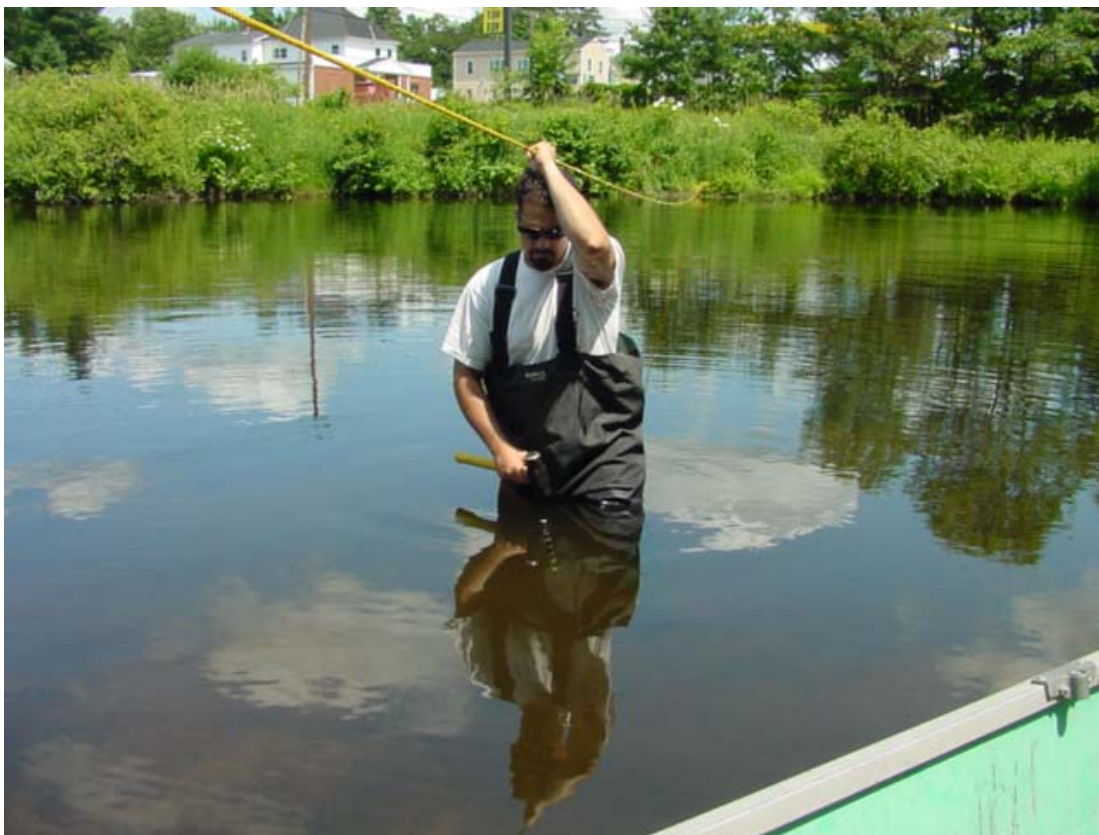
Photo No.: 33, Date: 6/29/04, Mean Flow at Souhegan River Gage: 72 cfs  
Description: View of river-right bank for transect T-2

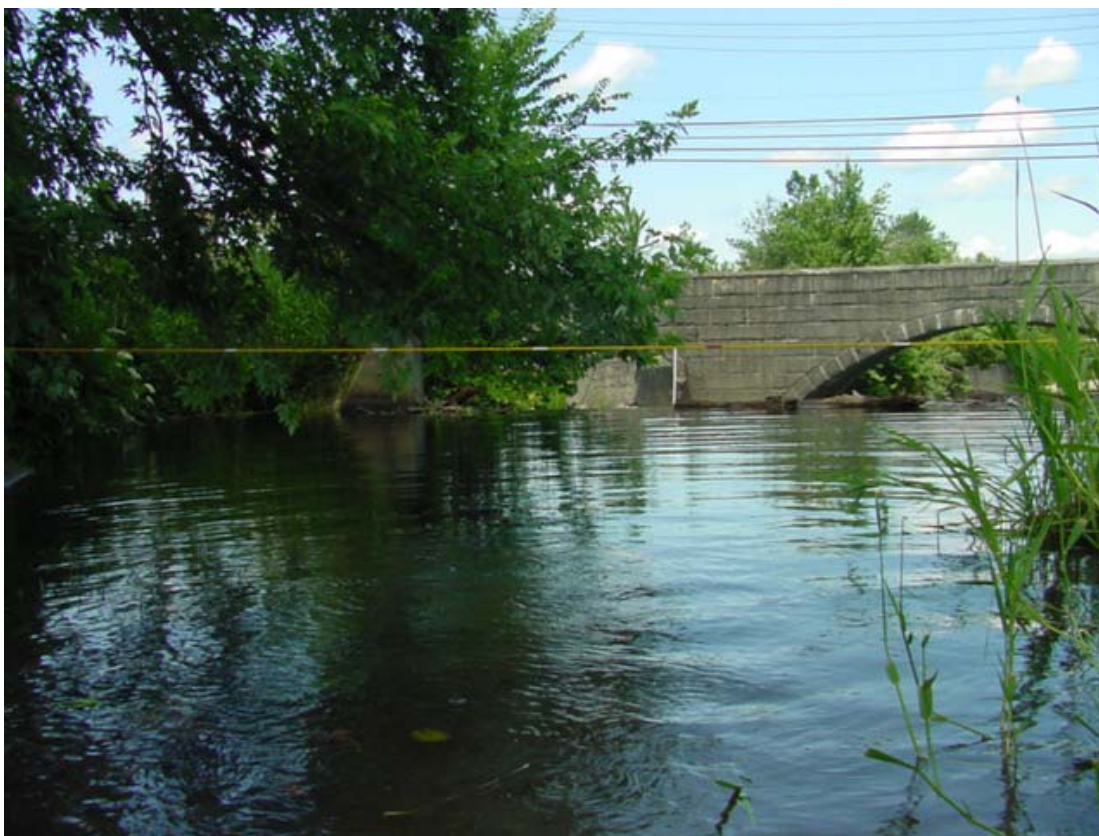
Photo No.: 34, Date: 6/29/04, Mean Flow at Souhegan River Gage: 72 cfs  
Description: Downstream view of transect T-1 and Chamberlain Bridge

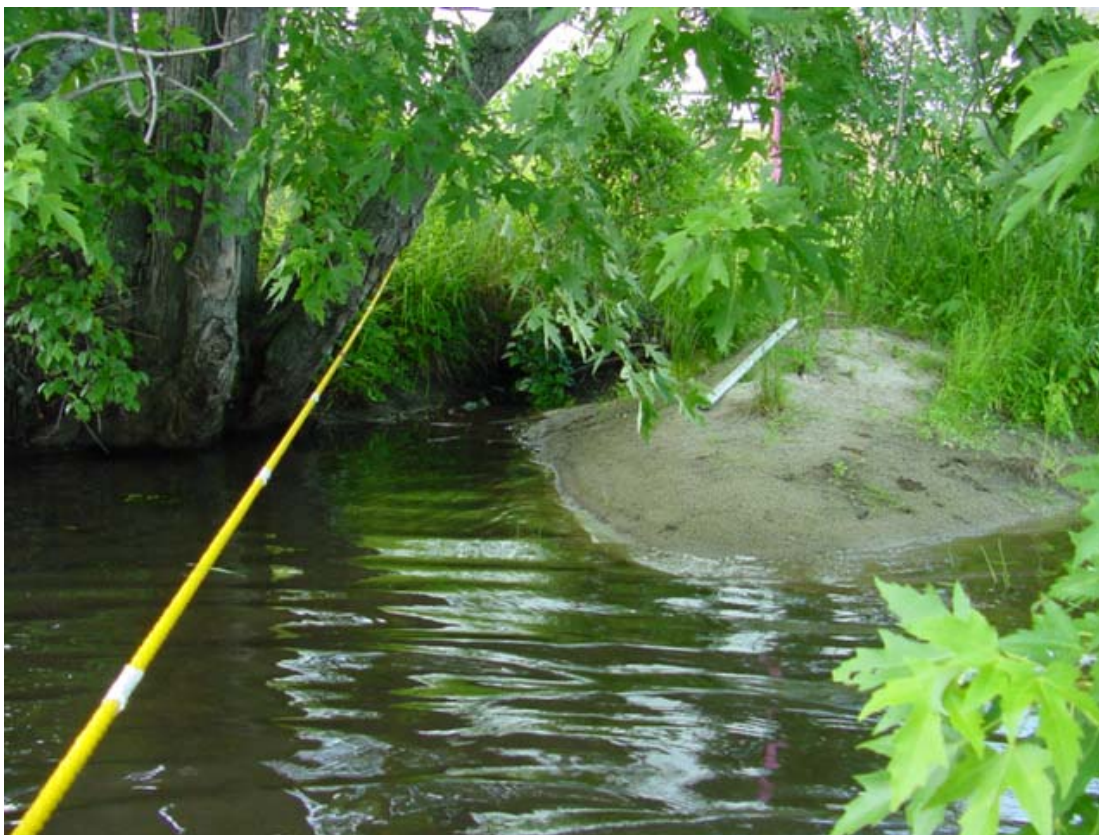
Photo No.: 35, Date: 6/29/04, Mean Flow at Souhegan River Gage: 72 cfs  
 Description: Looking across wetland outlet (transect T-1)

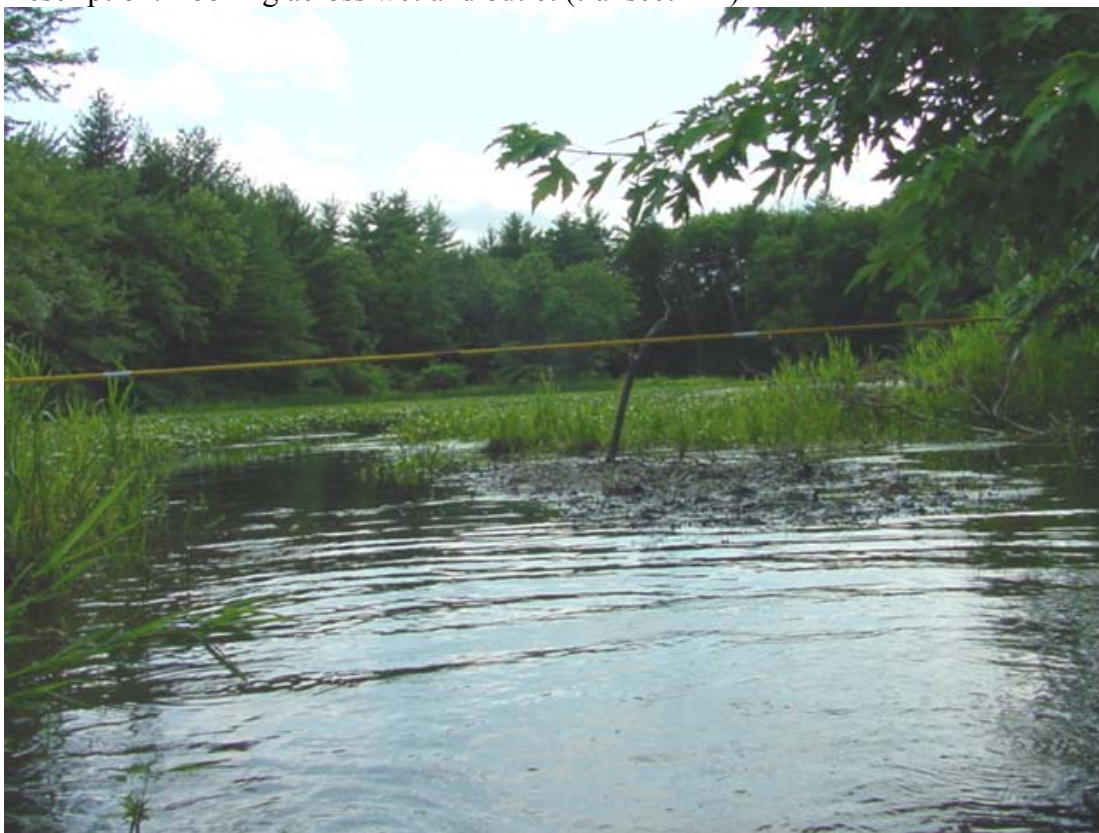
Photo No.: 36, Date: 6/29/04, Mean Flow at Souhegan River Gage: 72 cfs  
 Description: Upstream view of wetlands outlet (transect T-1)

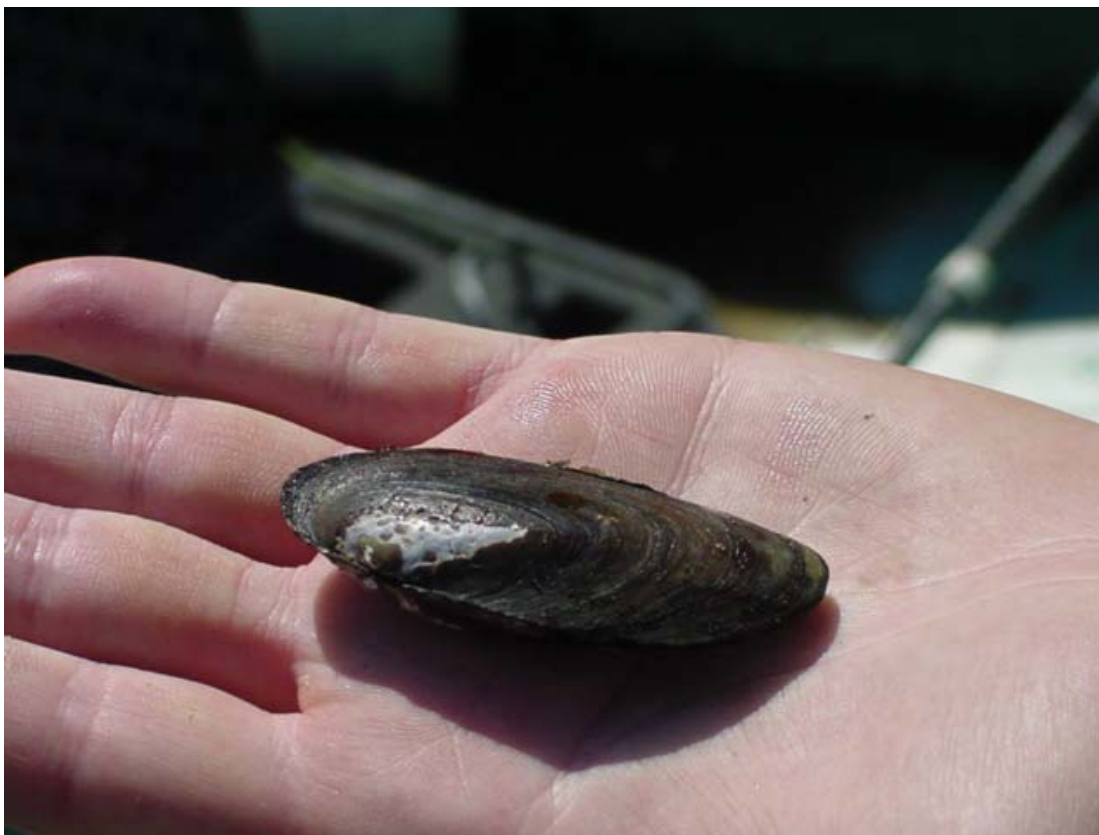
Photo No.:37, Date: 6/30/04, Mean Flow at Souhegan River Gage: 77 cfs  
Description: River mussel found at upstream of bar formations

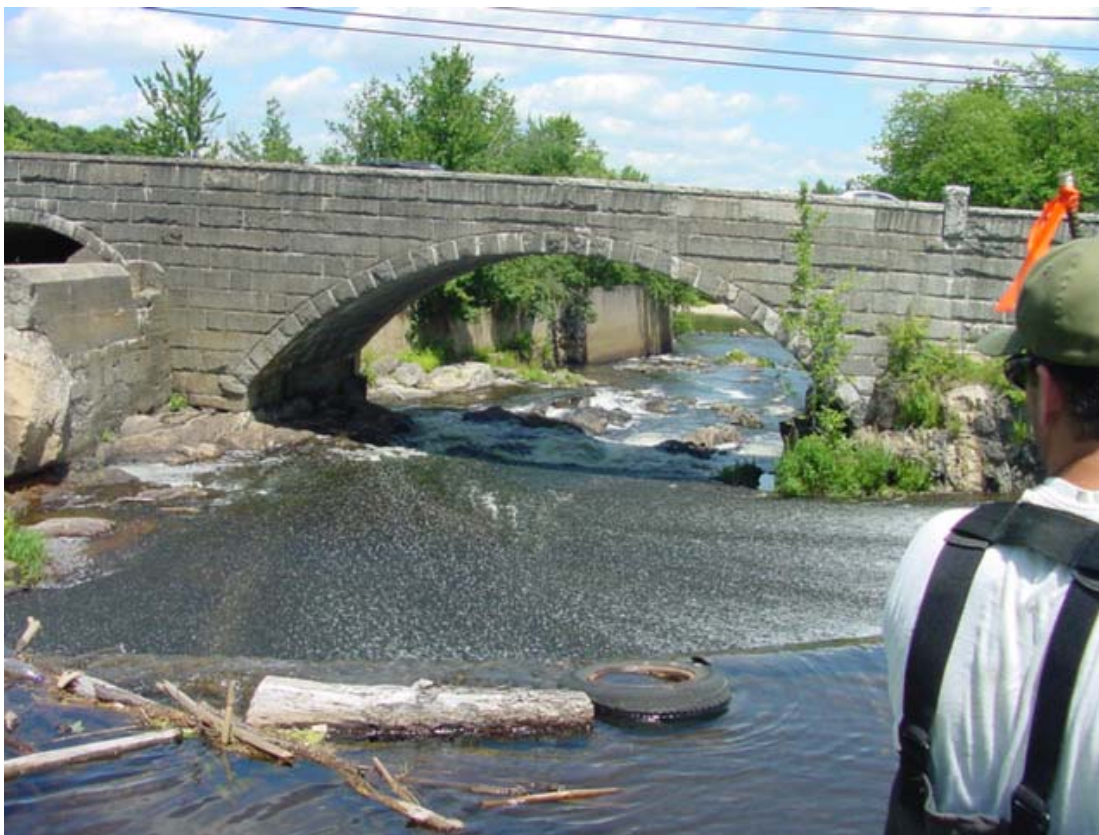
Photo No.: 39, Date: 6/30/04, Mean Flow at Souhegan River Gage: 77 cfs  
Description: Looking downstream from immediately behind the MVD

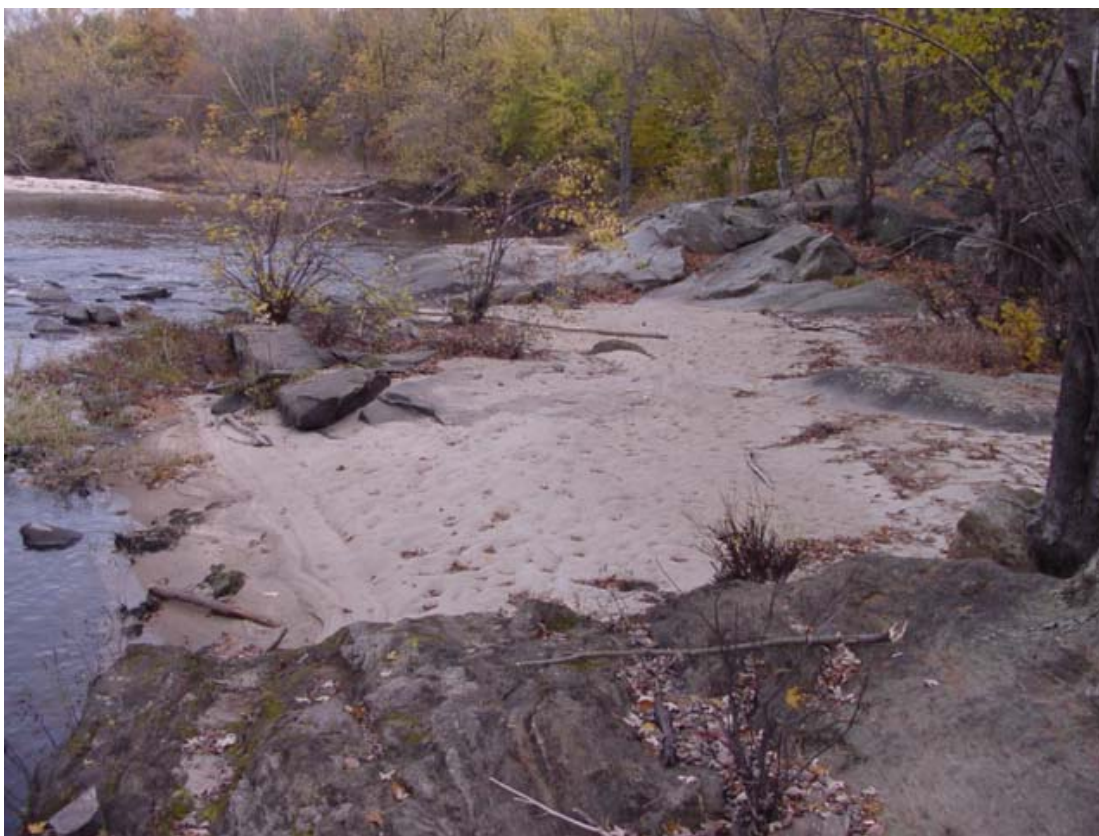
Photo No.: 40, Date: 10/27/04, Mean Flow at Souhegan River Gage: 102 cfs  
Description: Downstream right bank below rapid. Sand deposition.

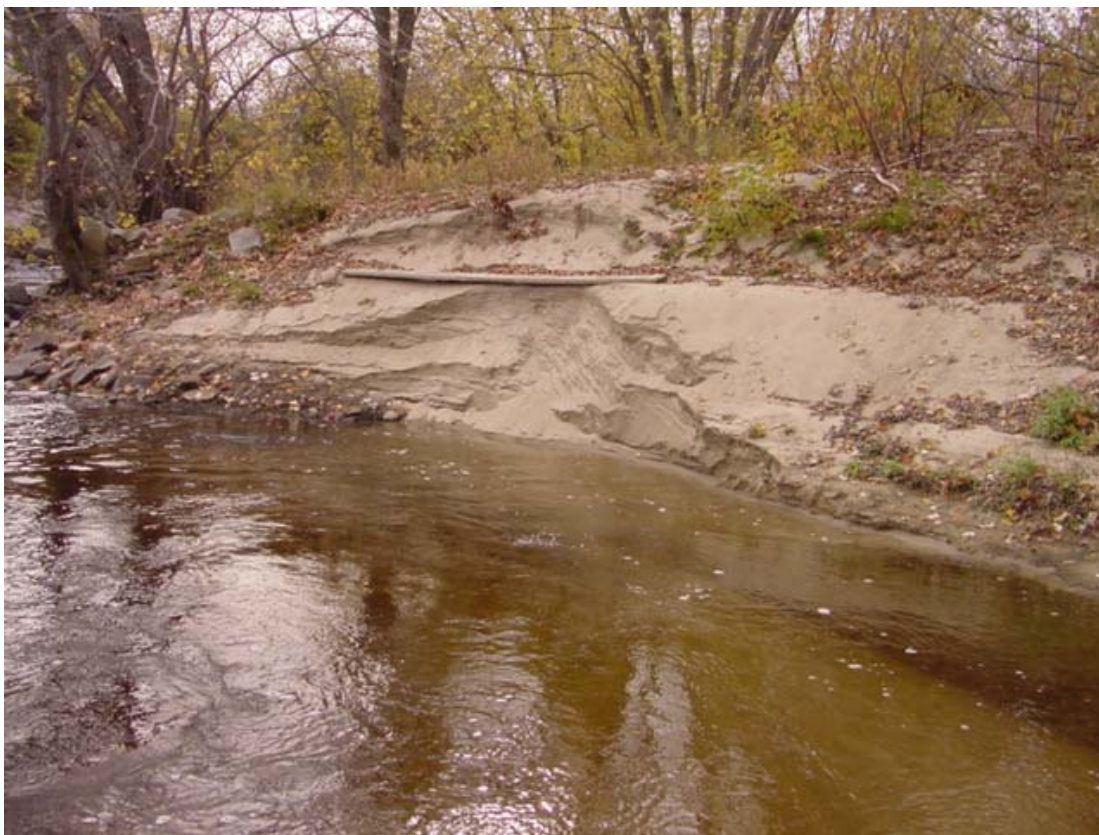
Photo No.: 41, Date: 10/27/04, Mean Flow at Souhegan River Gage: 102 cfs  
Description: Downstream left bank below rapid. Banks formed of sand..

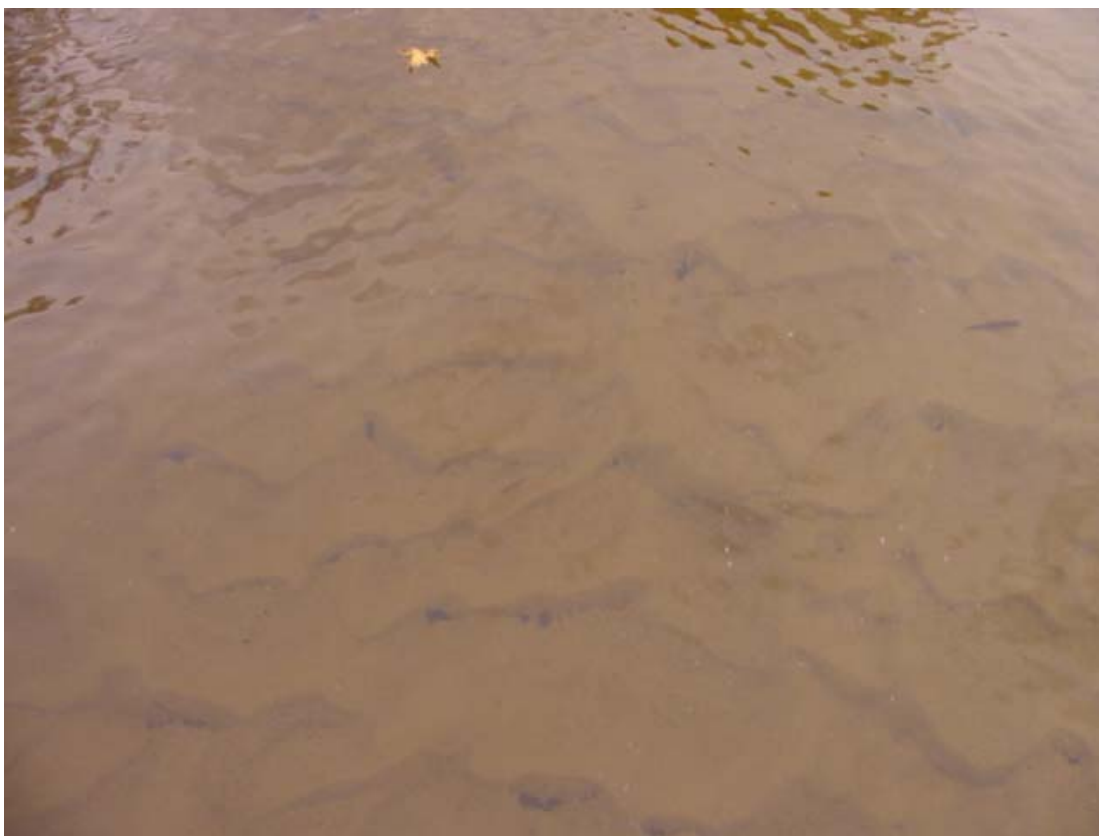
Photo No.: 42, Date: 10/27/04, Mean Flow at Souhegan River Gage: 102 cfs  
Description: Channel bed at confluence with Baboosic Brook. Sand bed; bedform is ripples.

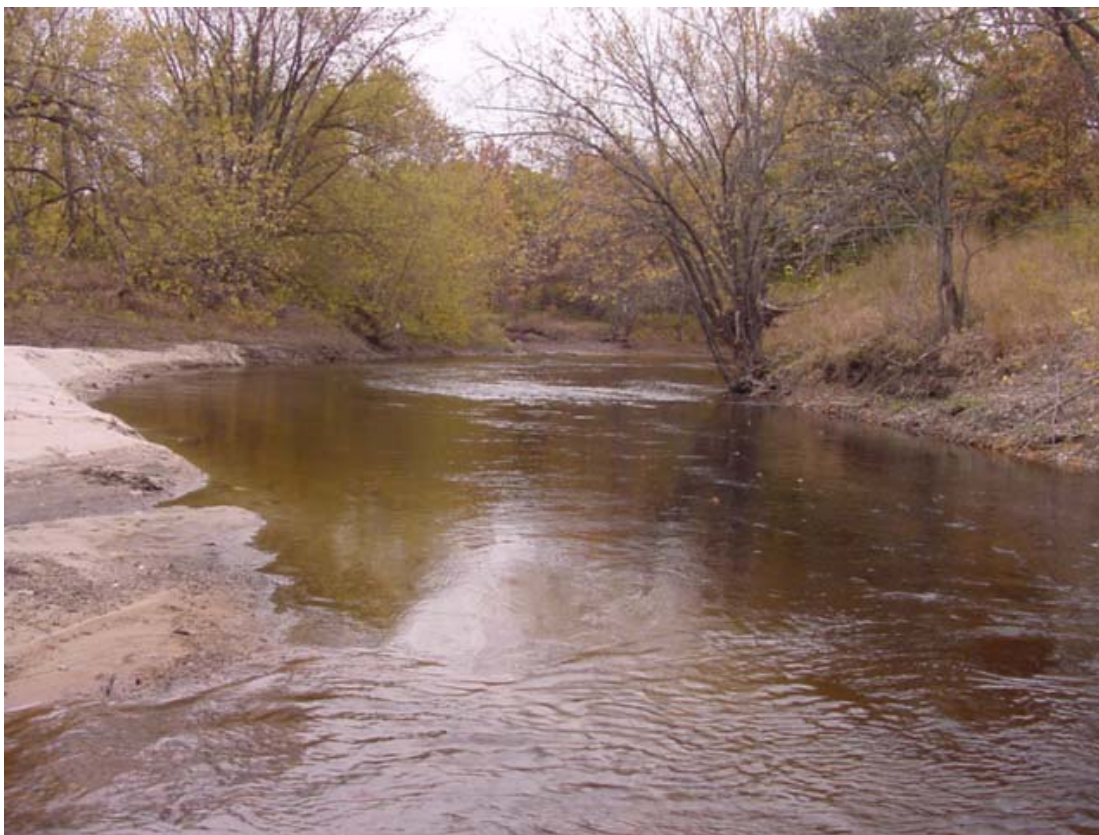
Photo No.: 43, Date: 10/27/04, Mean Flow at Souhegan River Gage: 102 cfs  
Description: View downstream (right channel) from right bank below rapid.

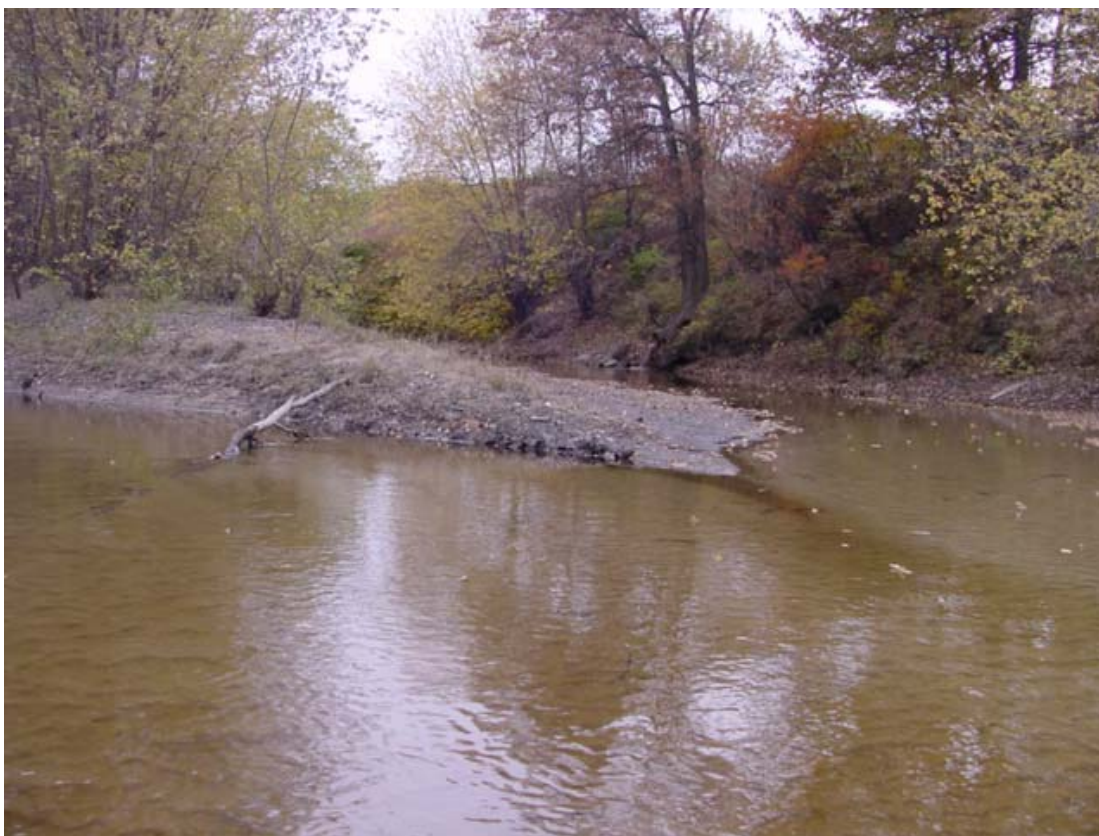
Photo No.: 44, Date: 10/27/04, Mean Flow at Souhegan River Gage: 102 cfs  
Description: Right and left channels rejoin at confluence with Baboosic Brook. (Upstream view)
